# RS8234

Product and Documentation Errata

**Documentation Affected:** RS8234 Data Sheet (28234-DSH-001-B)  
**Product Affected:** RS8234EBGD (28234-15), RS8234EBGC (28234-13),  
RS8234EBGB (28234-12), and RS8234EBG (28234-11)

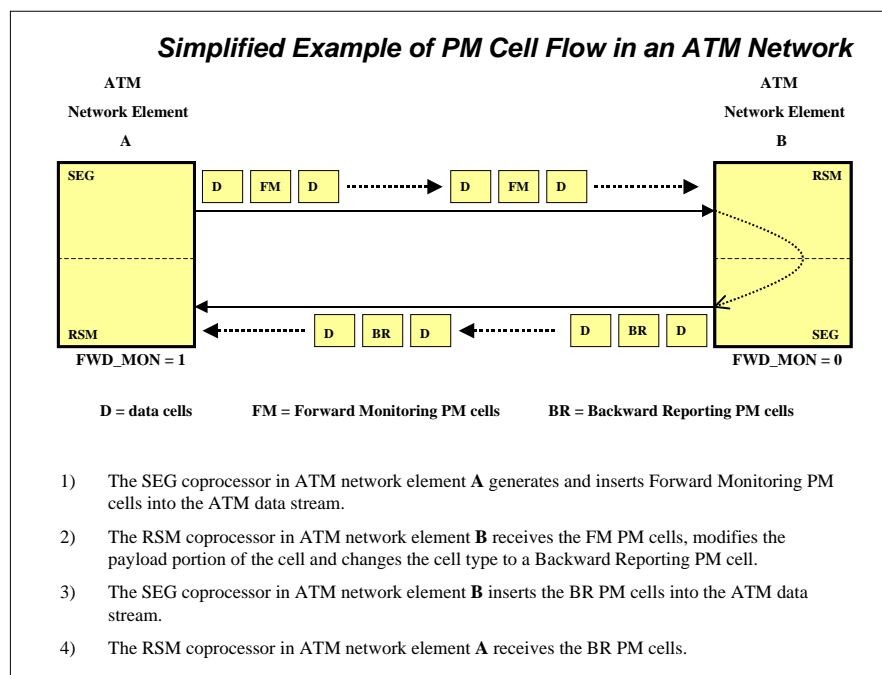
Figure 1-10. 2 ATM Network Elements (NE) Connected Full Duplex; NE A & NE B

When the PM function is “re-enabled” on an active VCC with Forward Monitoring enabled, the SAR may generate an erroneous BR PM cell. The following figure and subsequent steps, show the test scenario in which this problem was uncovered.

The generation of the erroneous BR PM cell occurs in operation number 10 above. NE B was previously enabled for PM activity and had received a Forward Monitoring (FM) PM cell during operation number 3. Also during operation number 3, NE B turned around the received FM PM cell and sourced a BR PM cell to NE A. As part of the FM PM to BR PM cell processing in NE B, the SAR had set two state variables (ACK\_PM & BCK\_PM) in the SEG VCC table. When NE B sources a packet in operation number 6, with PM turned off, the SAR resets the ACK\_PM bit, but does not reset the BCK\_PM bit. When PM is re-enabled on NE B the FM PM to BR PM mechanism in the SAR is out of synchronization. The next packet segmented by NE B results in an erroneous BR PM cell being sent before the first data cell of the packet. After the generation of the erroneous BR PM cell in NE B, the SAR FM PM to BR PM cell processing mechanism is resynchronized. In this scenario NE A would receive an unexpected BR PM cell.

Two possible workarounds are available for this errata item. The first workaround accepts the possibility of an erroneous BR PM cell generation with S/W awareness. The second workaround eliminates the generation of the erroneous BR PM cell by setting two state variable bits in the SEG VCC table to an initialization state.

1. An awareness of this anomaly needs to be built into the application/driver S/W. All of the expected FM PM and BR PM cells are sent and received and the contents and Status indications are correct. The generation of the erroneous BR PM cell does not cause any corruption within the normal PM cell processing, it merely shows up as an unexpected BR PM cell at the receiving ATM Network Element. When this happens simply discard this cell.

2. The SEG VCC needs to be in an idle state (not actively segmenting) when performing writes to the SEG VCC Table in order to avoid potential coherency problems within bytes lanes. The ACK\_PM (bit 23 of word 0) and the BCK\_PM (bit 30 of word 6) control bits in the SEG VCC Table need to be set to zero when re-enabling the PM function on the VCC with Forward Monitoring. This will eliminate the possible generation of an erroneous BR PM cell .
